# Assessment of flexible pavement of selected highways in Odo-Otin Local Government South-Western Nigeria

**Abstract**— This paper presents the flexible pavement of selected highways in Odo Otin Local Government Area, Osun State, Southwestern Nigeria. To achieve this, the study involved site observation, Pavement Condition Rating (labeled TP1-TP7), identification of types of failures or distress on the pavement, drainage assessment, and geotechnical studies of the selected Highways. Soil samples were collected from both the unfailed and failed section of the selected roads. The samples were subjected to the following laboratory tests; natural moisture content, sieve analysis, atterberg limit, specific gravity, compaction test using West African standard, unconfined compressive strength, and California bearing ratio. The study revealed that PCR rating scales for TP4, TP6, and TP7 were in good condition because there was less distress on the road. TP3 and TP were in satisfactory condition. TP1 and TP2 were observed to be in poor condition. Only road TP6 and TP7 have effective drainage, but it can be predicted for them to have a blockage or erode other roads in the nearest future due

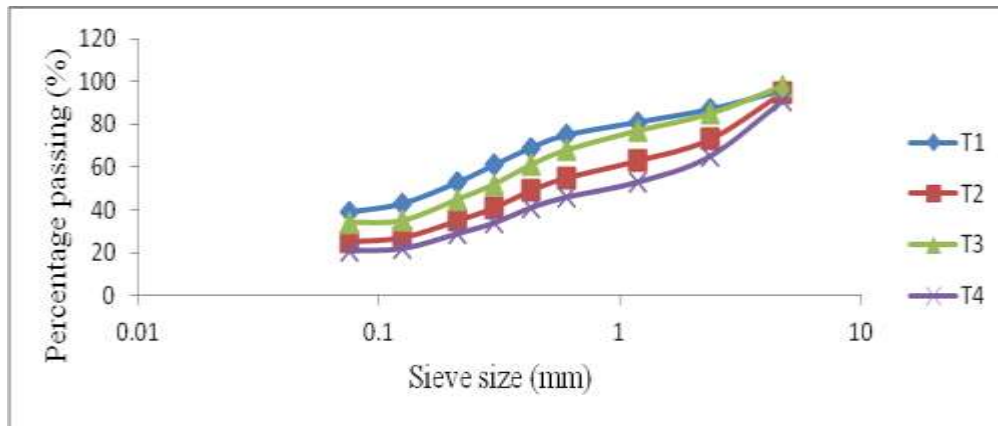
Fig. 2. Particle size distribution of the samples T1 to T4

The percentages of samples passing through No. 200 BS sieves for samples T1 to T13 are 38.8%, 24.6%, 34.2%, 20.6%, 31.2%, 29.8%, 27.6%, 31.6%, 33%, 19%, 36%, 33% and 8.8% with their graphs below. According to AASHTO classification, samples T2, T4 and T13 are A-1-b subgroup, samples T3, T6, T8, T9, T10 and T12 are A-2-4 subgroup, while samples T1, T11, T5 and T7 are A-4, A-4, A-2-7 and A-2-6 respectively while under USCS classification, samples T1, T2, T3, T11, T12 and T13 have a group symbol of SC-SM and group name silty clayey sand, samples T4, T6, T8 and T9 have group symbol of SM and group name silty sand, while samples T5, T7 and T10 have group symbol SC and group name clayey sand. Base on the AASHTO classification chart, it is noted all the samples except for samples T1 and T11 are excellent to good soils while samples T1 and T11 are fair to bad soils.

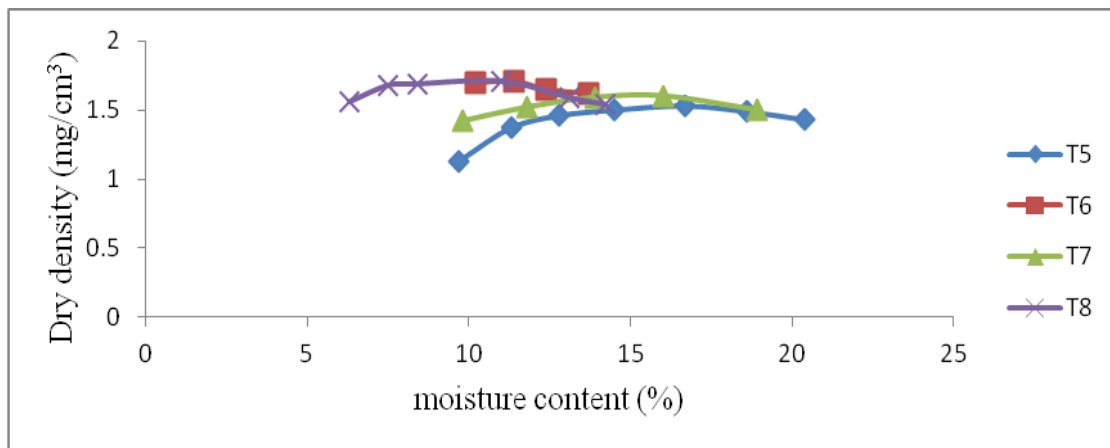
Fig. 6. Compaction curve of samples T5 and T8

Density (MDD) and the Optimum Moisture Content (OMC) of the various samples are listed below. The compaction curves for the analyzed soil samples show that sample T5 has the highest optimum moisture content

of 16.7% while T12 has the lowest optimum moisture content of 8%, sample T4 has the highest maximum dry density of 1.85Mg/cm<sup>3</sup> while sample T5 has the lowest maximum dry density of 1.53Mg/cm<sup>3</sup>.

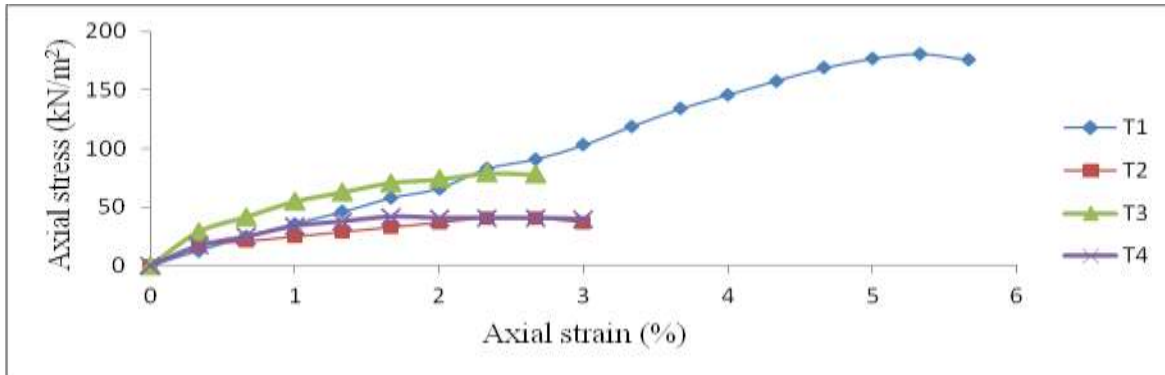
Fig. 8. Unconfined compressive strength graph of samples T1 and T4

The unconfined compressive strengths ( $q_u$ ) of samples T1 to T13 are 181kN/m<sup>2</sup>, 41kN/m<sup>2</sup>, 79kN/m<sup>2</sup>, 42kN/m<sup>2</sup>, 101kN/m<sup>2</sup>, 45kN/m<sup>2</sup>, 89kN/m<sup>2</sup>, 53kN/m<sup>2</sup>, 53kN/m<sup>2</sup>,

53kN/m<sup>2</sup>, 137kN/m<sup>2</sup>, 61kN/m<sup>2</sup> and 42kN/m<sup>2</sup> with the graph of the samples as shown below. From the result above it was observed that soil with more cohesive properties tends to have more unconfined compressive strength.

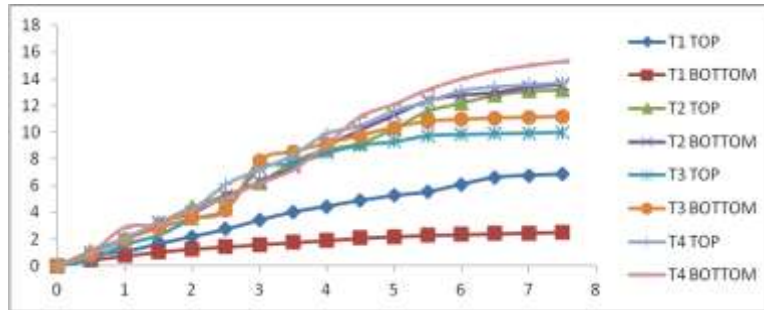
Fig. 11. California Bearing Ratio of T1 to T4

The California bearing ratio result of samples T1 to T13 are 28.2%, 53%, 49.4%, 59.6%, 33.2%, 53.3%, 47.2%, 55.3%, 53.6%, 46.3%, 26.8%, 47.8% and 55.9% with the graph shown below. It was recommended that

for soaked samples the values of CBR for subgrade, sub base and road base should not be less than 10%, 30% and 80% respectively, which implies that the entire sample can either be used for subgrade or sub base or both.

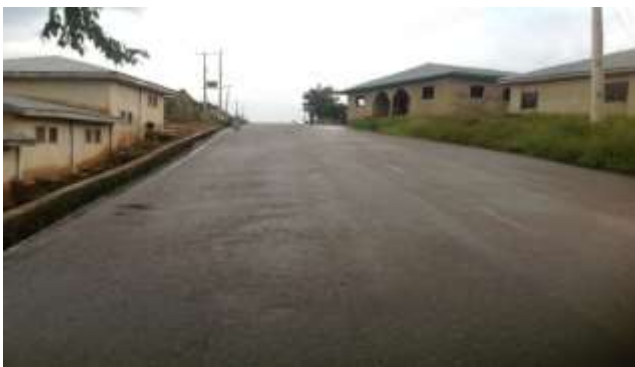
Plate 1: Showing a pavement in good working condition with adequate drainage facility in place (School road).

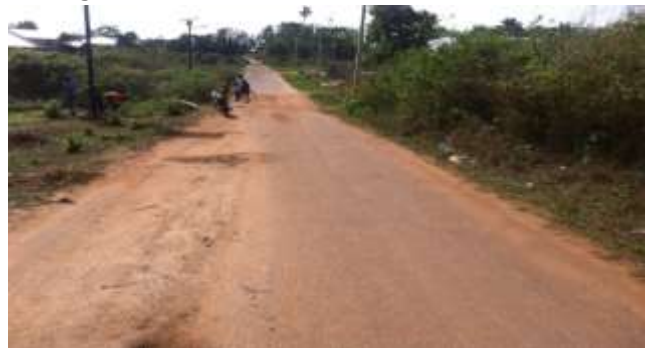
Plate 2: Showing the view of Olopade Oyinlola road with potholes

- i. Road pavement having little distress should be quickly treated and those beyond treatment should be properly rehabilitated or redesigned.
- ii. Proper and adequate construction of drainage and linking the drainage to a good flow water body
- iii. More soil samples should be collected within the case study area for detailed work on their engineering properties.
- iv. The ministry of works (Highway Department) should enforce strict compliance to construction specification and appropriate construction practice and use of adequate materials
- v. All newly constructed roads should be thoroughly supervised by qualified engineers for safe and efficient road construction.
- vi. Osun Road Maintenance Agency (ORMA) should develop a program for maintaining and evaluating the condition of existing and newly constructed flexible pavements within the Local Government Area.

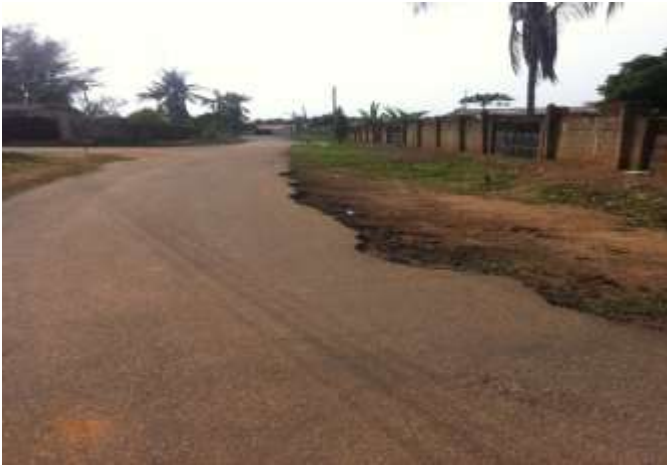
Plate 3: Showing the view of Cedars Road with edge cracks along the road

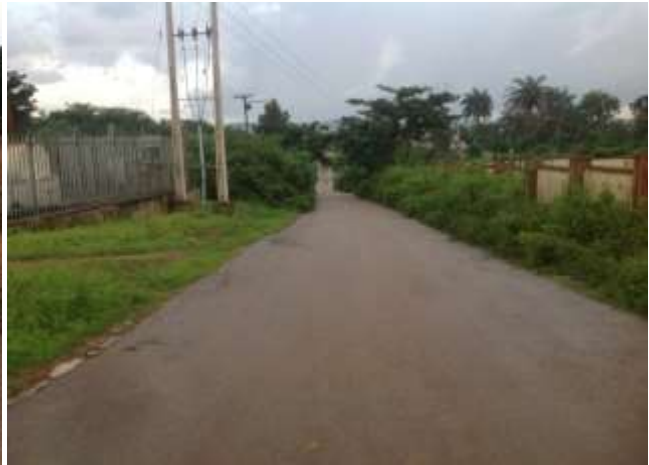
Plate 4: Showing the view of Okesina Road surface with little defects along road

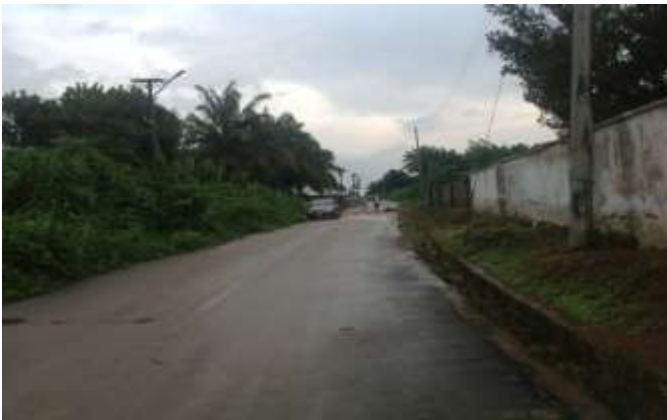
Plate 5: Showing the view of Makanjuola Road with drainage

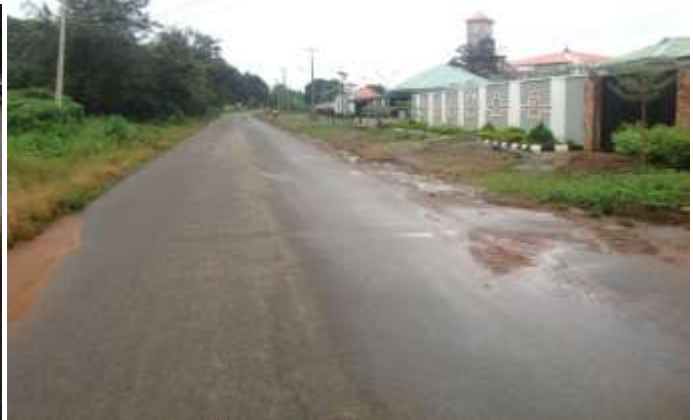
Based on the outcome of this study, only road TP6 and TP7 have effective drainage, but can be predicted for them to have blockage or erode other roads in the nearest future due to no discharge outlet. For other roads, they have no drainage which leads to major causes of some distress all around those roads.

Plate 6: Showing the view of Igbaye Road with no drainage

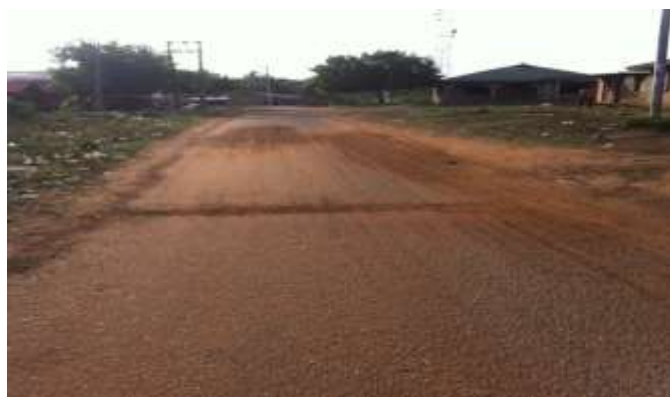
Plate 6: Showing the view of Iyalaje Road with surface defect
